Distribution System Lead Mapping

RE: Lead Mapping of Distribution System

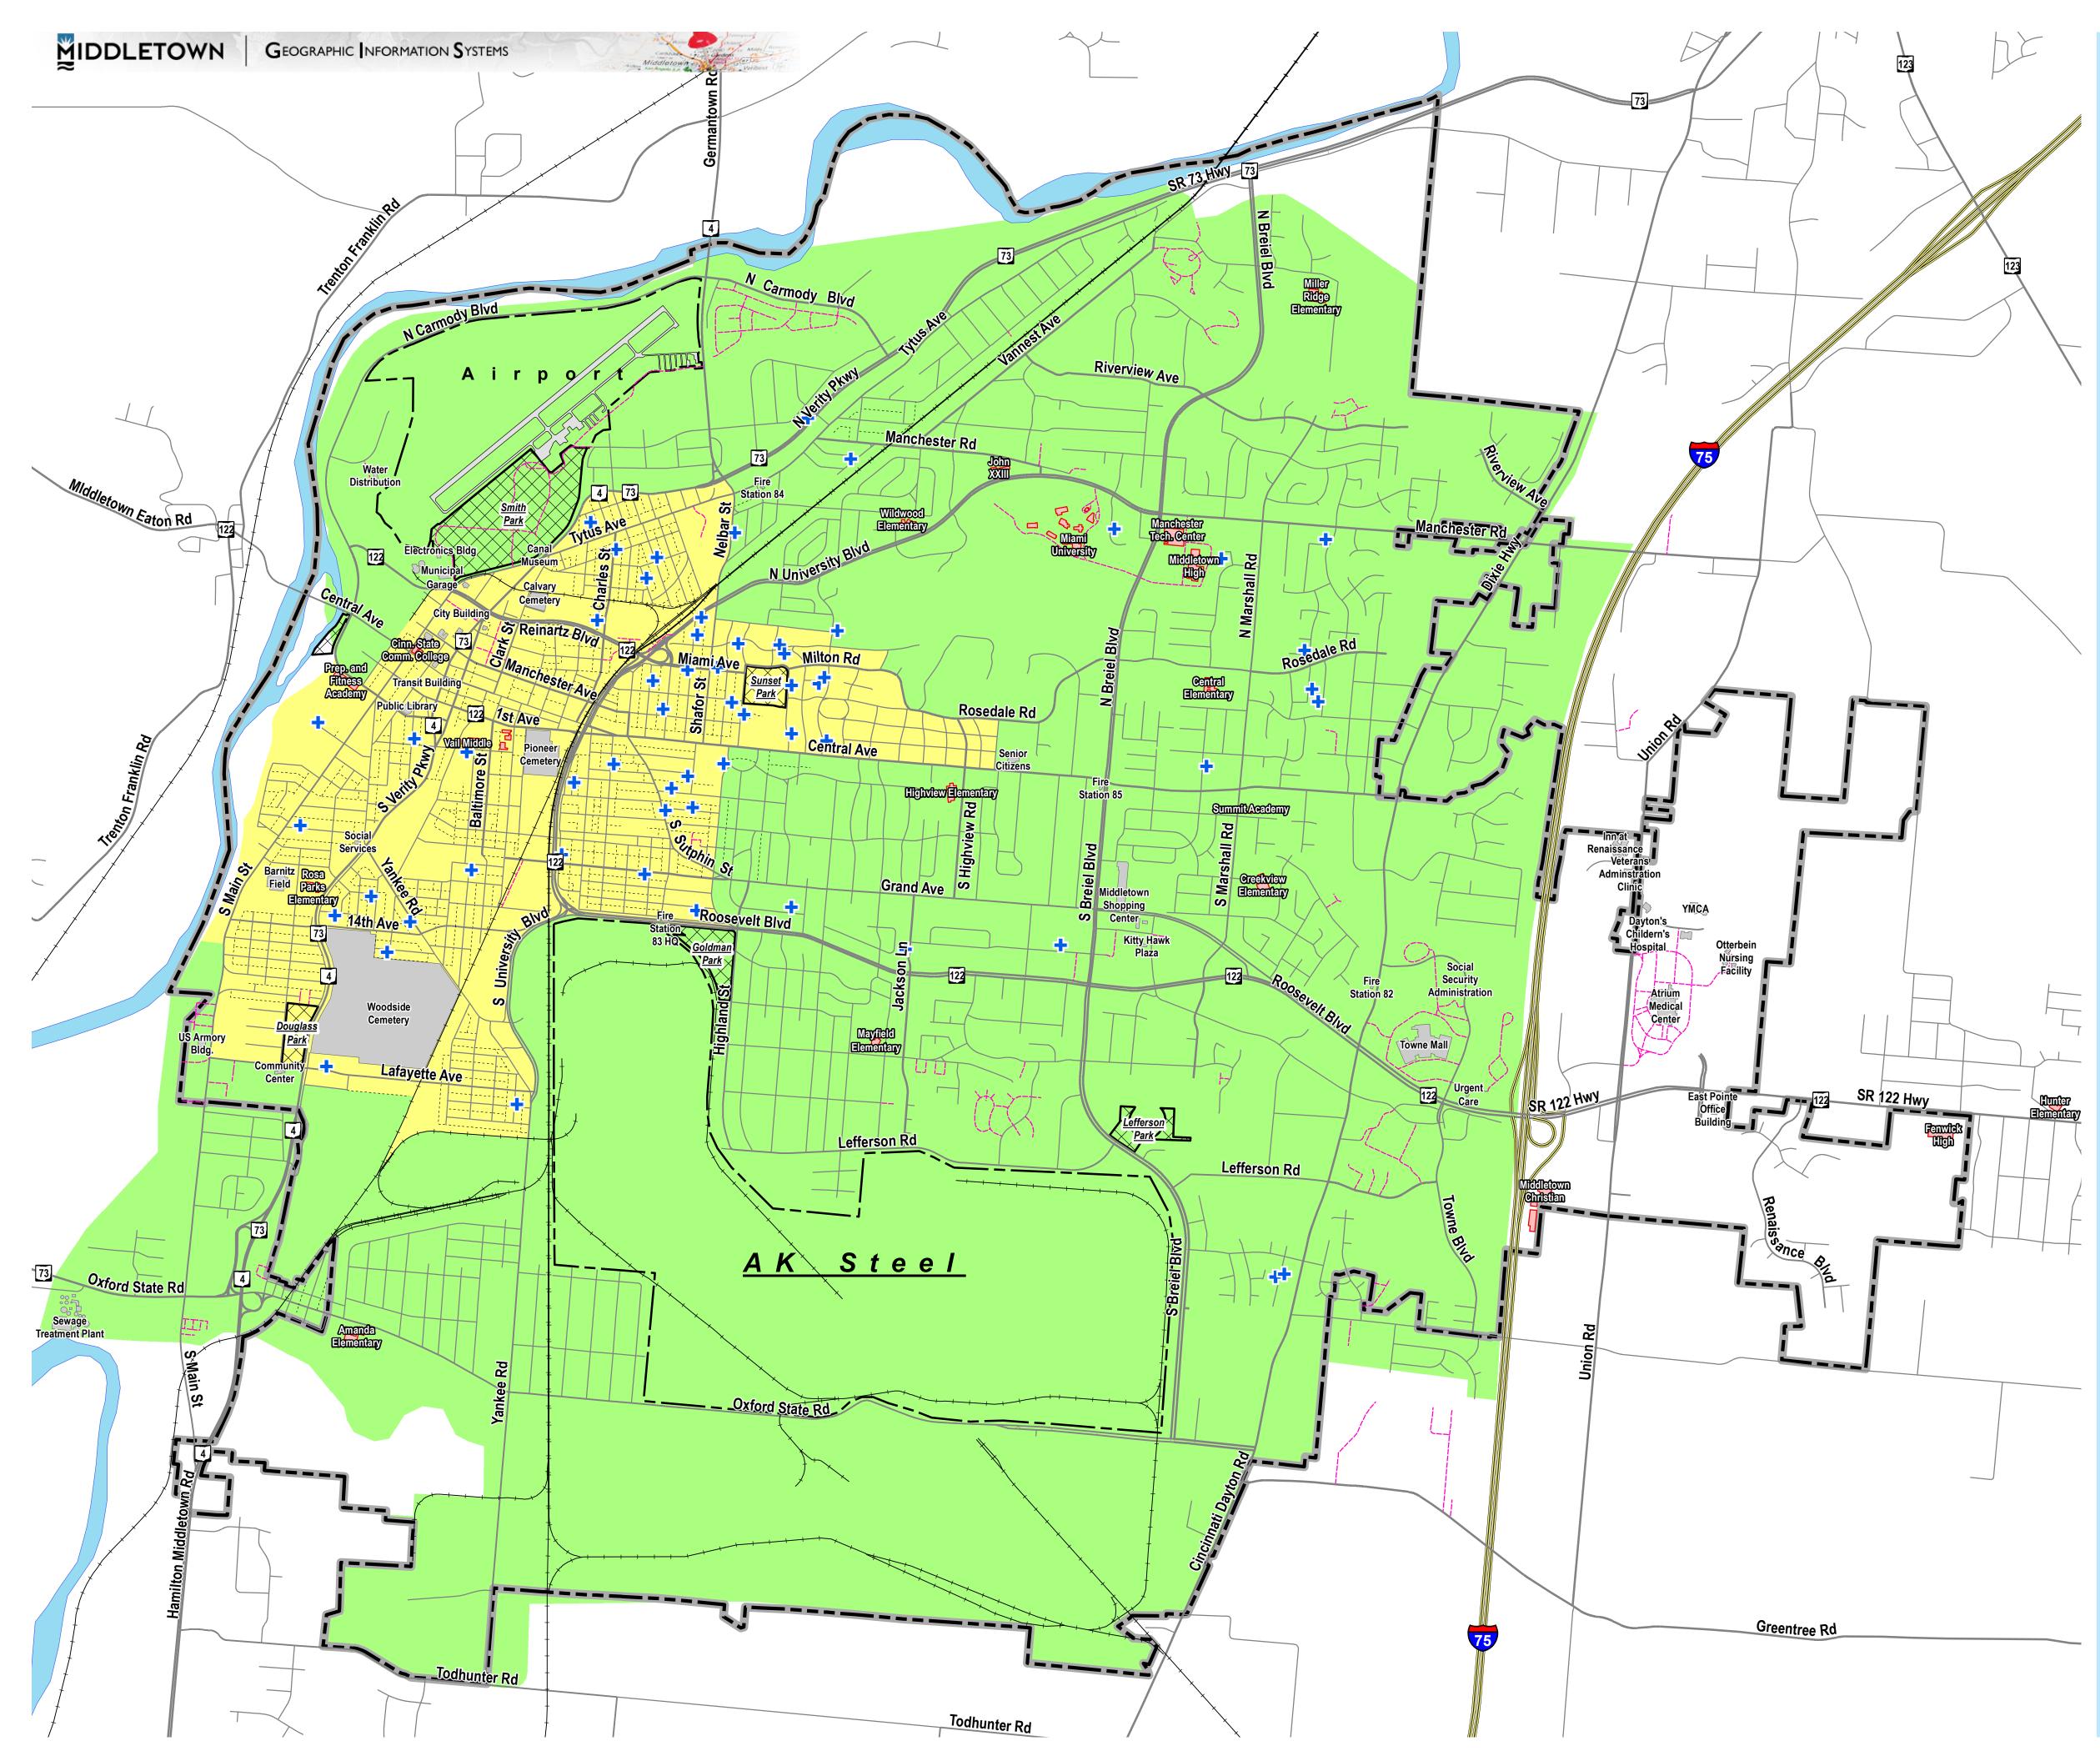
A map of the Middletown distribution system is attached to this report. The map is color coded with areas of the system known or likely to have lead service lines. Middletown will continue to collect data and update the map as individual locations with Lead lines are discovered or reported to us. The areas of the map color coded yellow contain an unknown number of Lead service lines and no data is currently available to perform Public/Private side color coding for individual buildings.
