Village of Belle Center OH
LEAD MAPPING OF DISTRIBUTION SYSTEM MARCH 2017

↑
North
PWS ID# OH4600012

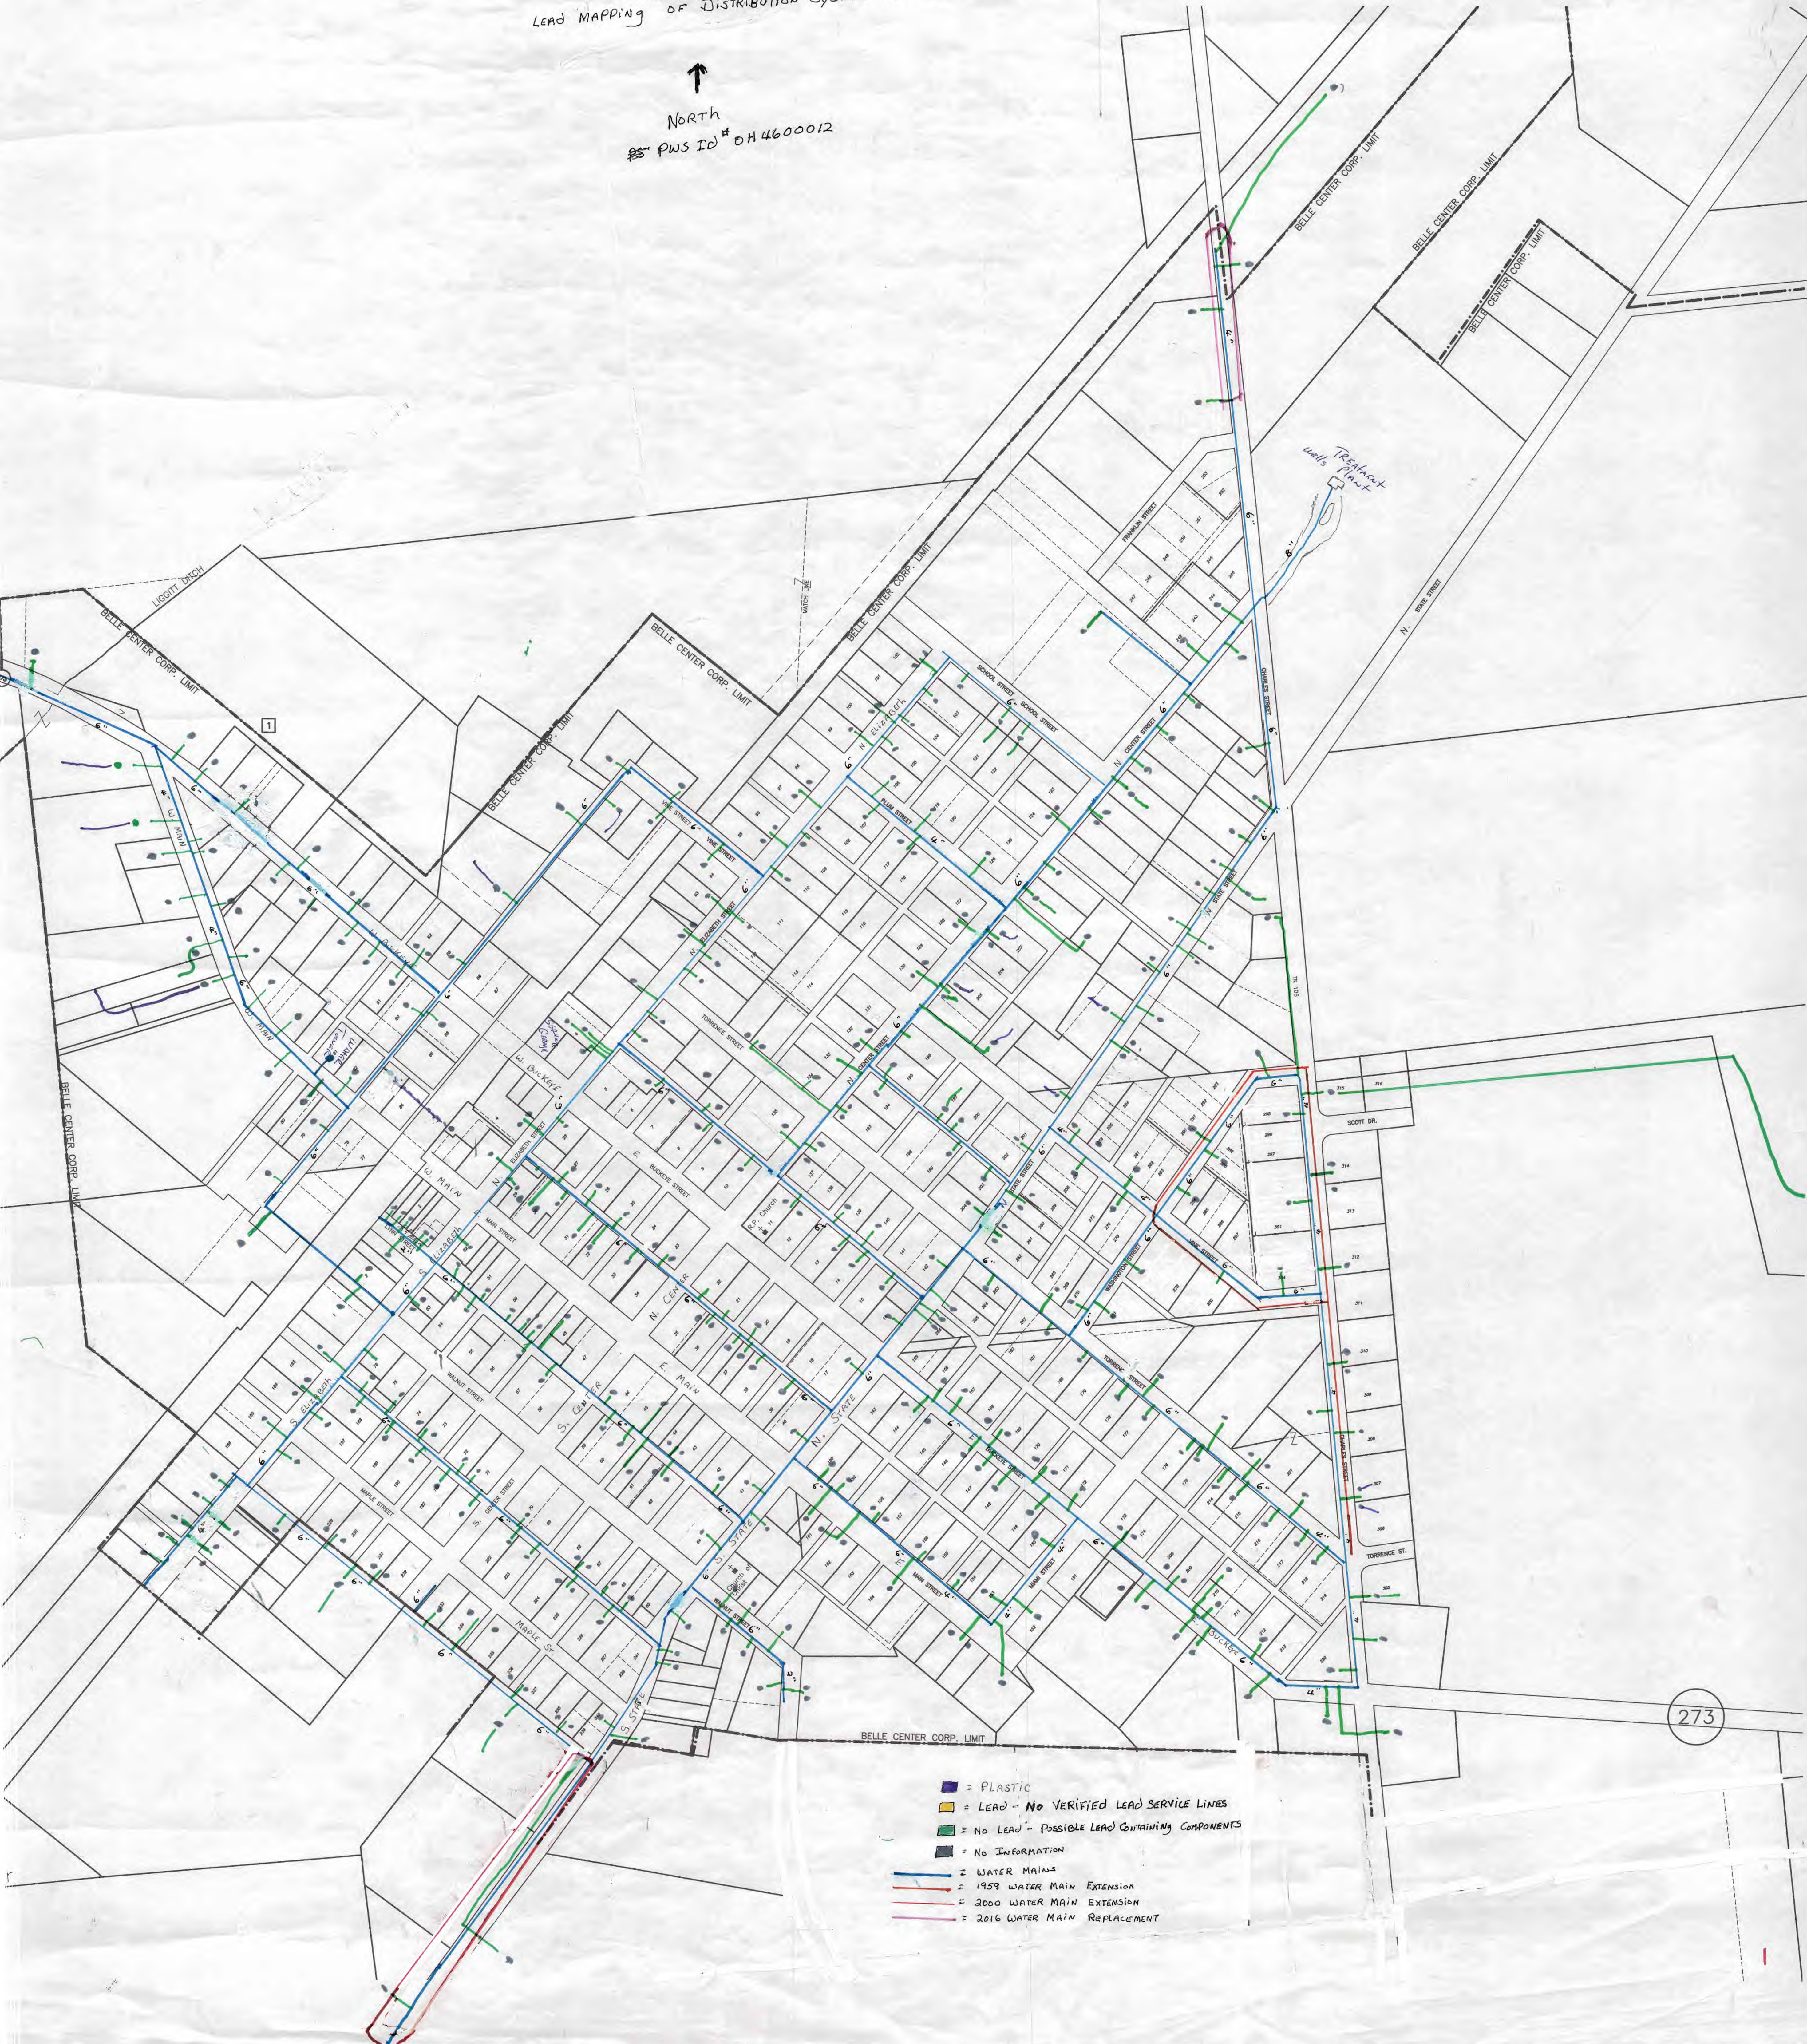
The Belle Center Water System was installed in 1938 by the WPA. The mains are 8", 6", 4" and 2" made of cast iron. All of the services we have found and have records of, from the corp stop to the meter pits, have been copper. After examining our old maps, records and the excavation of water mains and meter services, no lead lines have ever been discovered.

In 1959 a new cast iron main was installed, which picked up a section of East Vine, Washington and Charles Streets. This is outlined in Orange on the map.

In June of 2000 we extended a 6" main out South State Street to pick up a home. This is outlined in Red on the map.

In May of 2016 we removed a section 2" main and replaced it with a 4" section on the north end of Charles Street. This is outlined in Pink on the map.

The color Green on the map represent areas containing no known lead components, but have the possibility of lead containing components on the owner's service side.

Yellow is not used on this map because we have no known verified lead service lines.
