RE: EDGERTON VILLAGE
Report
Drinking Water Program
Williams County
PWS ID: OH8600312

Re: HB-512 Lead and Copper Map Updates
Edgerton, Ohio
PWS# OH8600312
PDG Job No. 161000-00081

Village of Edgerton Distribution System
Lead & Copper Mapping HB - 512
PWS # OH8600312

NARRATIVE for 2017 LEAD MAPPING

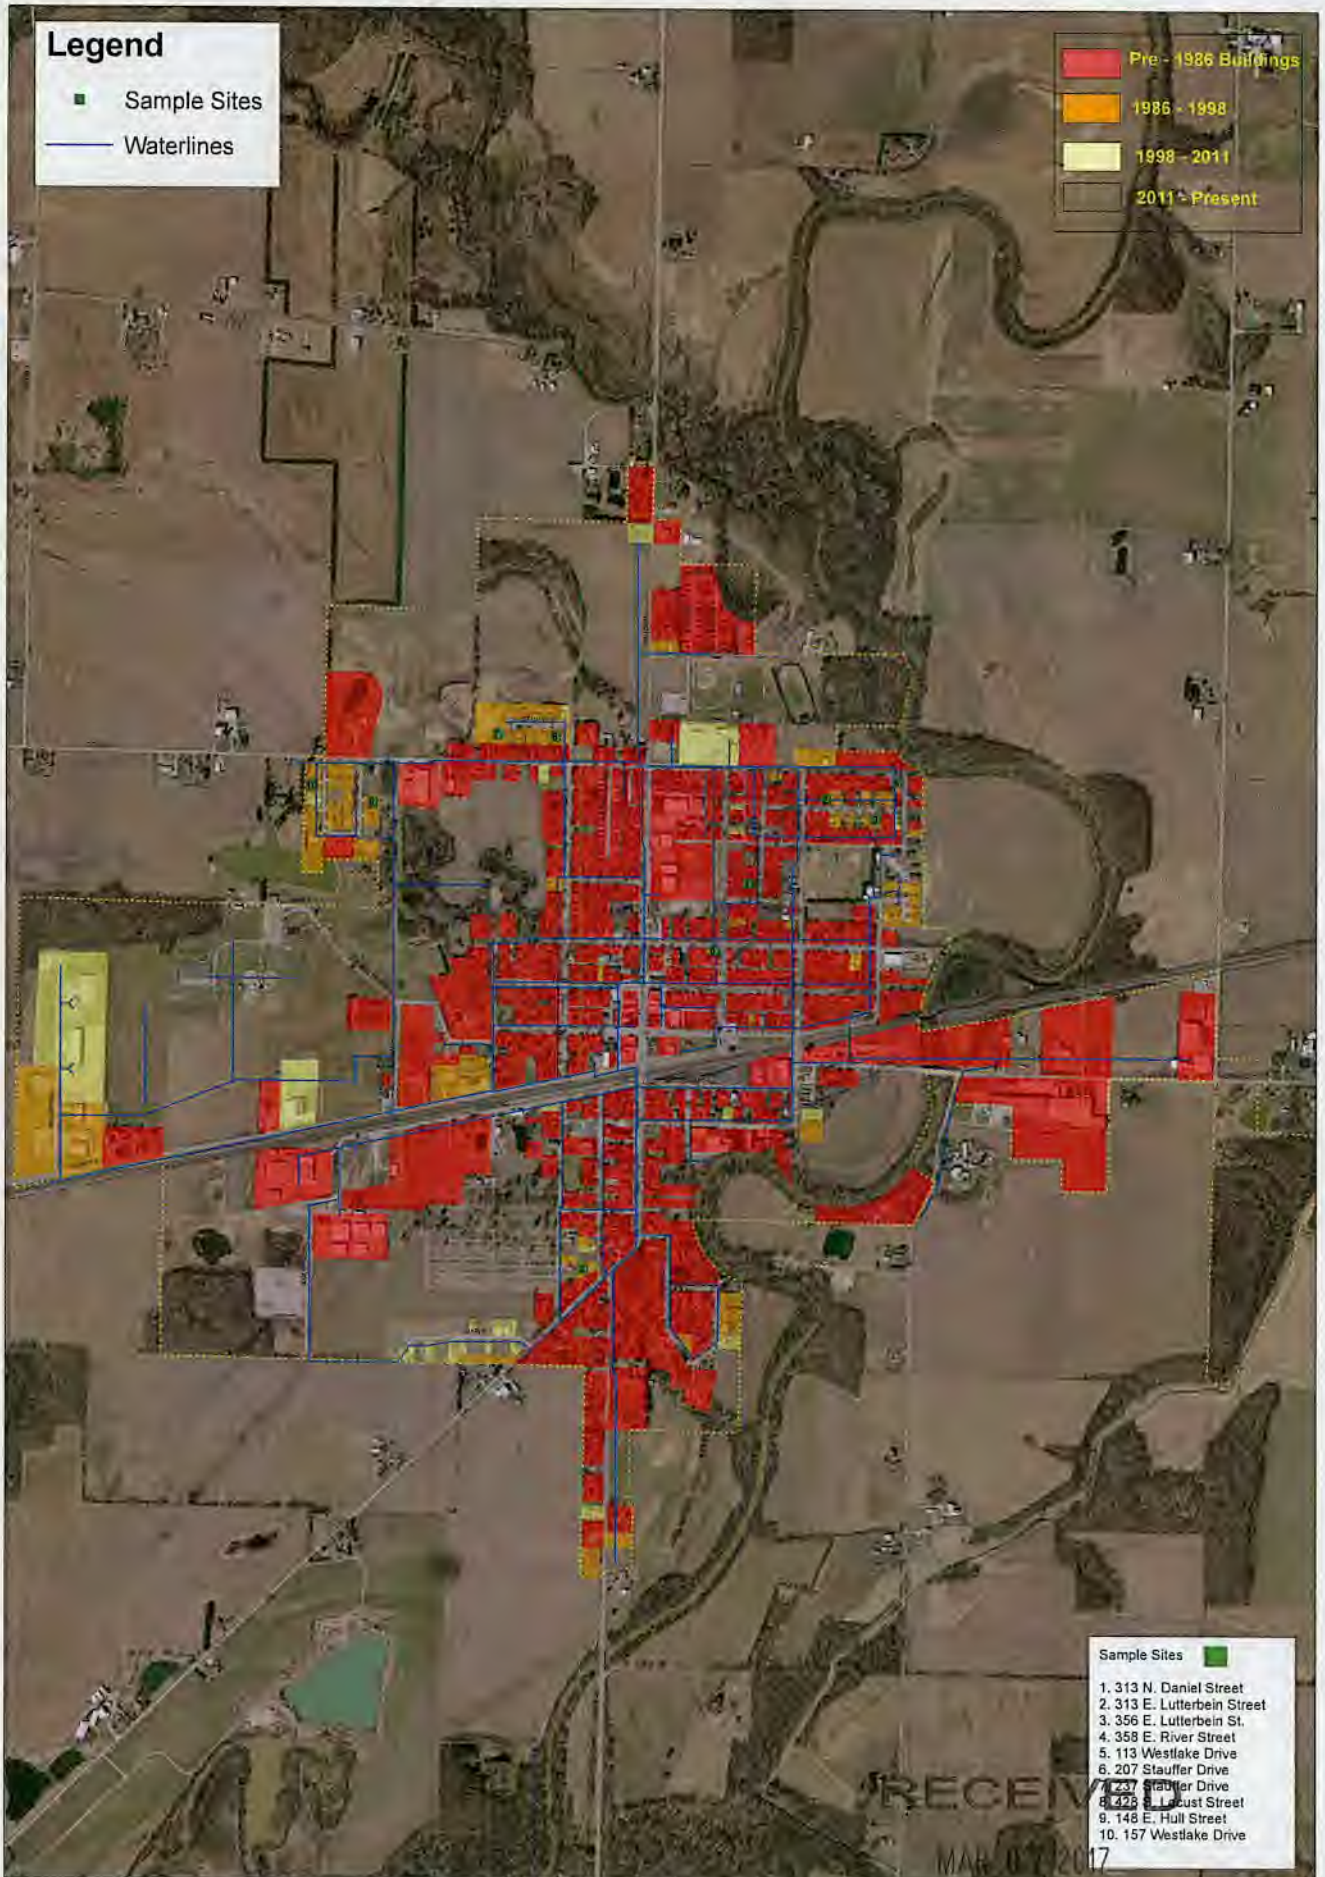
Legend

- Sample Sites
- Waterlines

- Pre - 1986 Buildings
- 1986 - 1998
- 1998 - 2011
- 2011 - Present

- Sample Sites**
1. 313 N. Daniel Street
 2. 313 E. Lutterbein Street
 3. 356 E. Lutterbein St.
 4. 358 E. River Street
 5. 113 Westlake Drive
 6. 207 Stauffer Drive
 7. 237 Stauffer Drive
 8. 228 E. Locust Street
 9. 148 E. Hull Street
 10. 157 Westlake Drive

*Disclaimer: Building Age Inferred from data provided by the City.

Buildings served by PWS likely to contain lead solder, plumbing or fixtures: The map submitted details by parcel, homes and buildings built within the specified time frames. Those structures built within the timeframes determined to have the potential of lead solder, plumbing or fixtures beyond the service lateral are detailed based on structure age information obtained from the Williams County Auditor's office and local knowledge of the Village.

Description of areas of the PWSD where susceptible buildings are located: Buildings that may or may not have lead solder, fixtures or plumbing are located in most of the service area of the Village.
