Lead Mapping Narrative: 2017

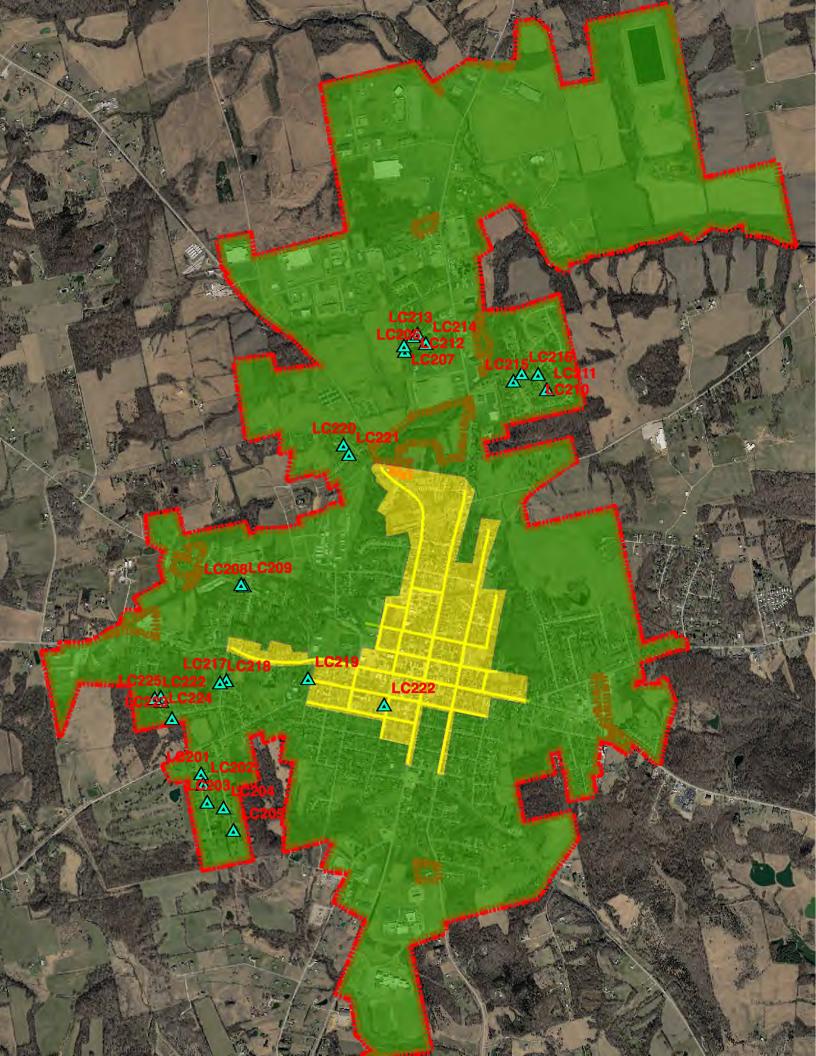
The City of Hillsboro Lead Map includes a highlighted area in Red which depicts our service area, and a highlighted area in Yellow which depicts our known area that contains, or has contained in the past, lead service lines and lead joints in the water mains. Visual inspection during uncovering of lines is our only form of identification (all lead service lines that have been uncovered, have been replaced at such time) since service line data that was recorded when installed does not include what the service line is made from. The City of Hillsboro has had very few new taps(homes or businesses) installed since 2014, which leads us to believe that virtually the whole city should be considered to have plumbing fixtures that would or could contain some lead. The map also has our current sample points identified with a Blue triangle. These sample points correspond to the SMP that was submitted, which includes all data related to that point. The map is depicted with North at the top of the page, with High St. (US 62) running north and south through town, and Main St. (US 50) running east and west through town, intersecting in the City's downtown, which is in the center of the Yellow highlighted area of the map.
