RE: Westbrook Country Club
Report
Drinking Water Program
Richland County
PWS ID: OH7036112

WestBrook Country Club

1st Floor

2nd Floor

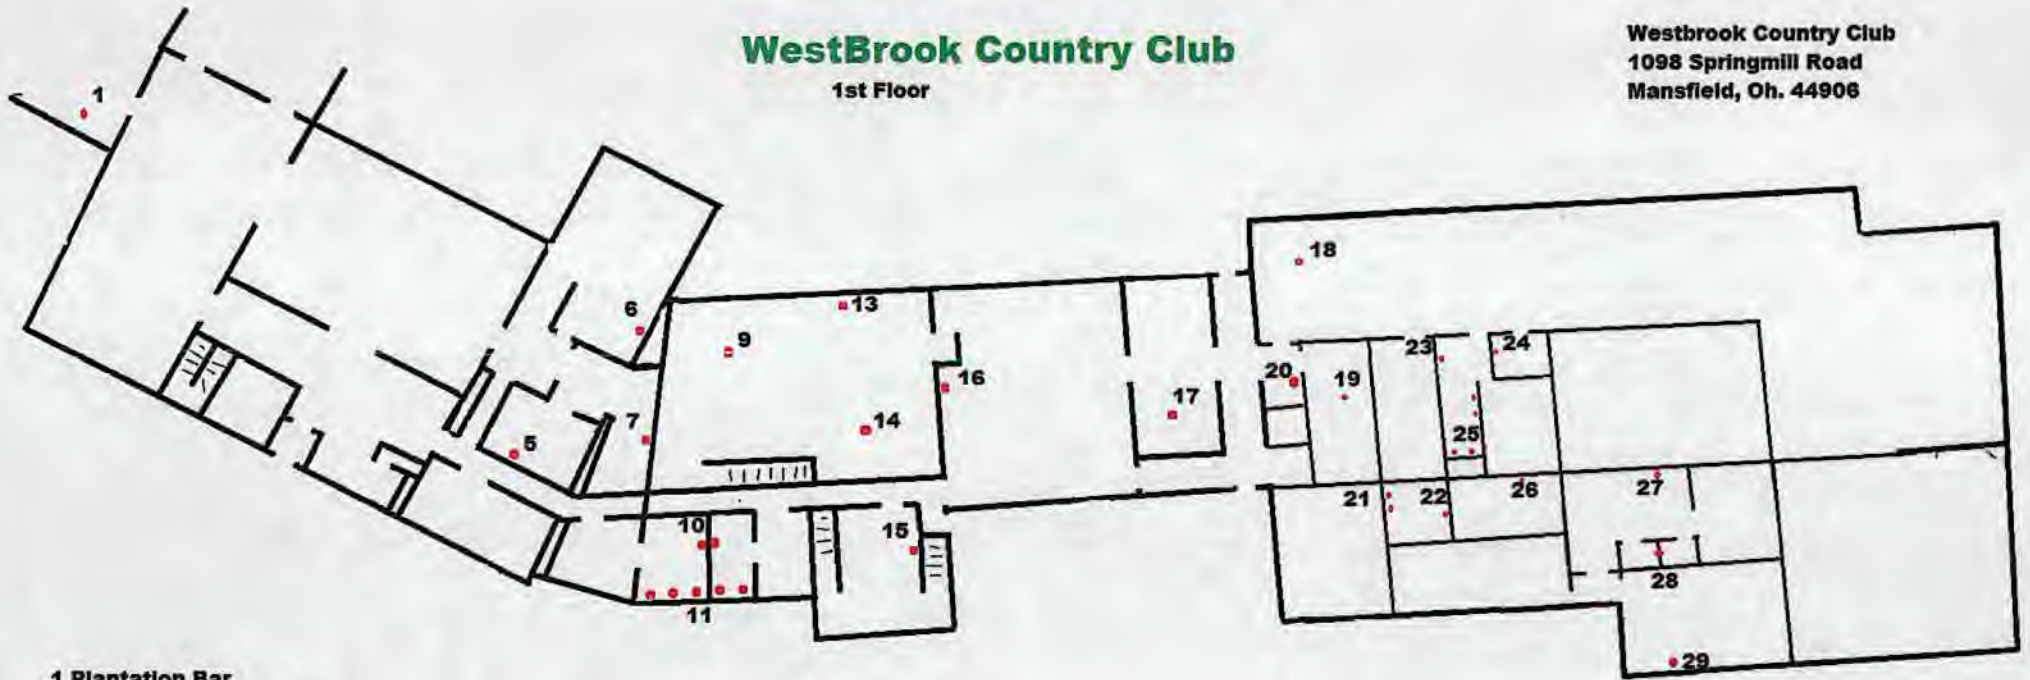
- 1 Plantation Bar
- 5 1st Floor Server coffee
- 6 1st Floor Lounge Bar
- 7 1st Floor Server Sink
- 9 1st Floor Dish washer
- 10 Mens & Womans Restroom sinks
- 11 Mens & womans Restroom Toilets & Urinals
- 13 1st Floor Kitchen Sink (cold side)
- 14 1st Floor Kitchen Sink (hot side)
- 15 1st Floor Ice Machine
- 16 1st Floor Grill Room Sink
- 17 1st Floor Grill Bar Sink
- 18 1st Floor Ross Room Bar
- 19 1st Floor Boys Locker Room sink
- 20 1st Floor Rossroom Coffee
- 21 1st Floor Ladies Locker Room Toilets
- 22 1st Floor Ladies Locker Room Sink
- 23 1st Floor Mens Lockerroom Sink
- 24 1st Floor Shoe shione Sink
- 25 1st Floor Mens lockerroom Toilets & urinals
- 26 1st Floor Mens & Ladies Locckerroom Showers
- 27 1st Floor Ladies Lockerroom Sinks
- 28 1st Floor Ladies Lockerroom Toilets
- 29 1st Floor Girls Lockerroom Sinks
- 30 Pool House toilets & Sinks PECS pipe installed 2014

Red = Copper pipe lead solder

All copper pipe is original construction 1942

Blue = Plastic Pipe

Green = Galvanized Pipe

All Galvanized pipe is original construction 1942

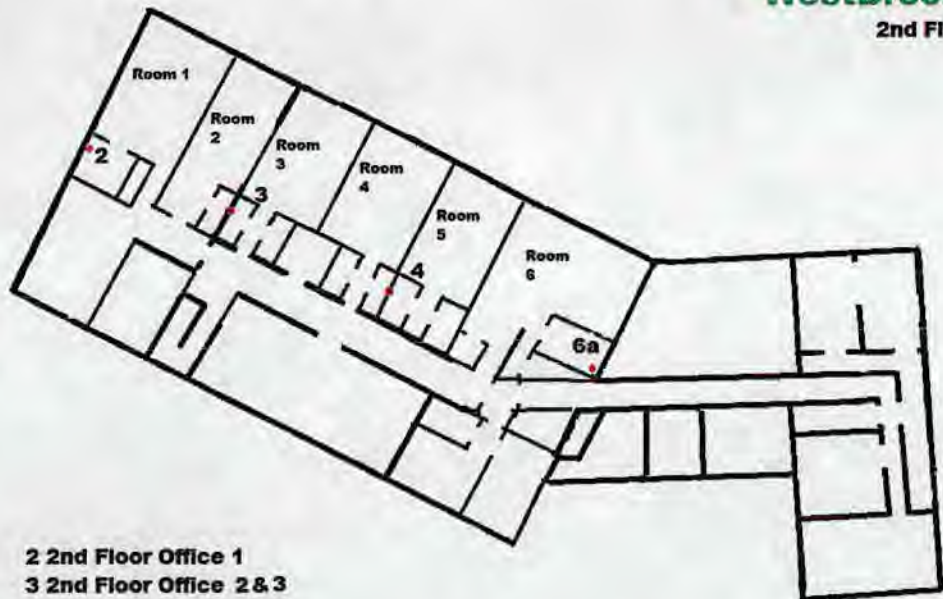
- 2 2nd Floor Office 1
- 3 2nd Floor Office 2 & 3
- 4 2nd Floor Office 4 & 5
- 6a 2nd floor room 6

Red = Copper pipe lead solder

All copper pipe is original construction 1942

Blue = Plastic Pipe

Green = Galvanized Pipe

All Galvanized pipe is original construction 1942
